UPPER OCONOMOWOC RIVER NUTRIENT AND SEDIMENT STUDY

**SOUTHEASTERN WISCONSIN
REGIONAL PLANNING COMMISSION**

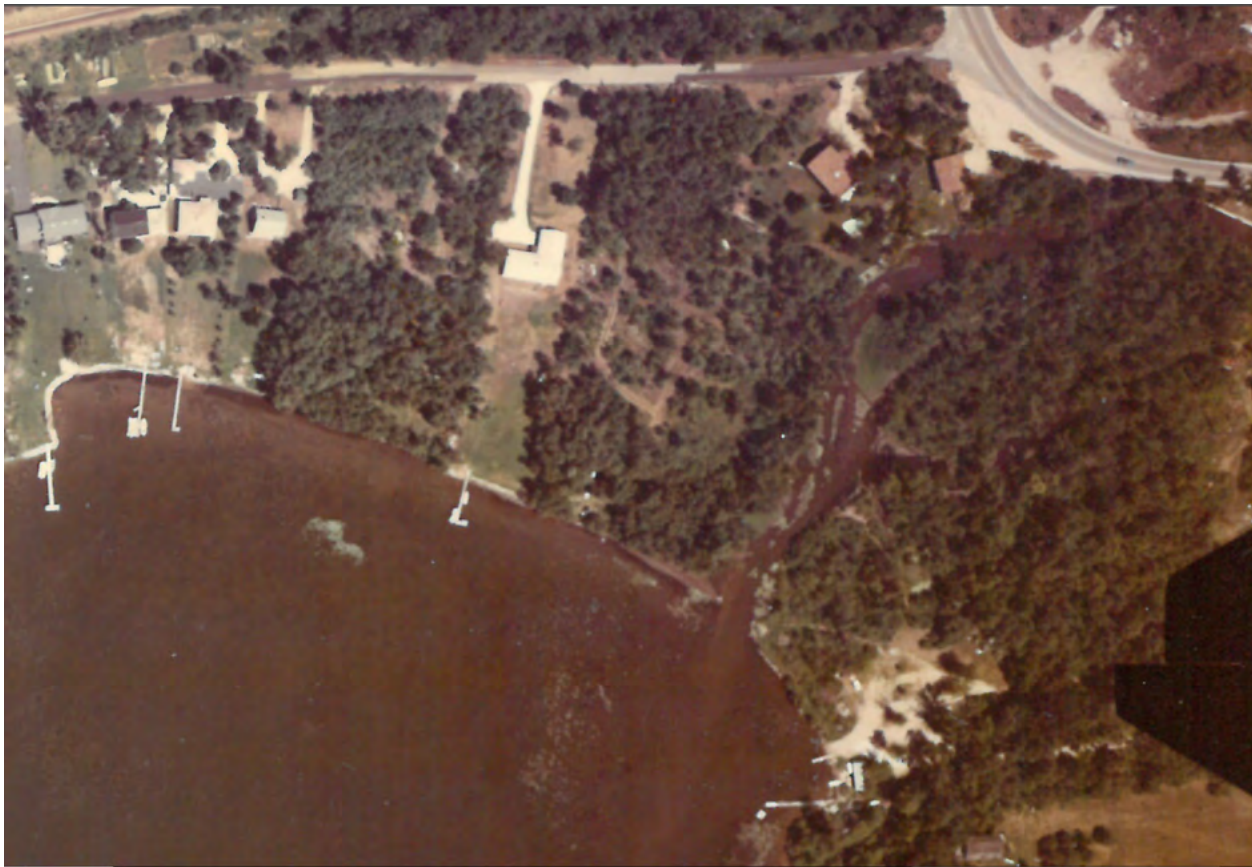
Figure 1.1
Upper Oconomowoc River Confluence with North Lake: August 2, 1976

Note: Sediment bars can be seen forming a braided channel condition within the River before it enters North Lake confluence.

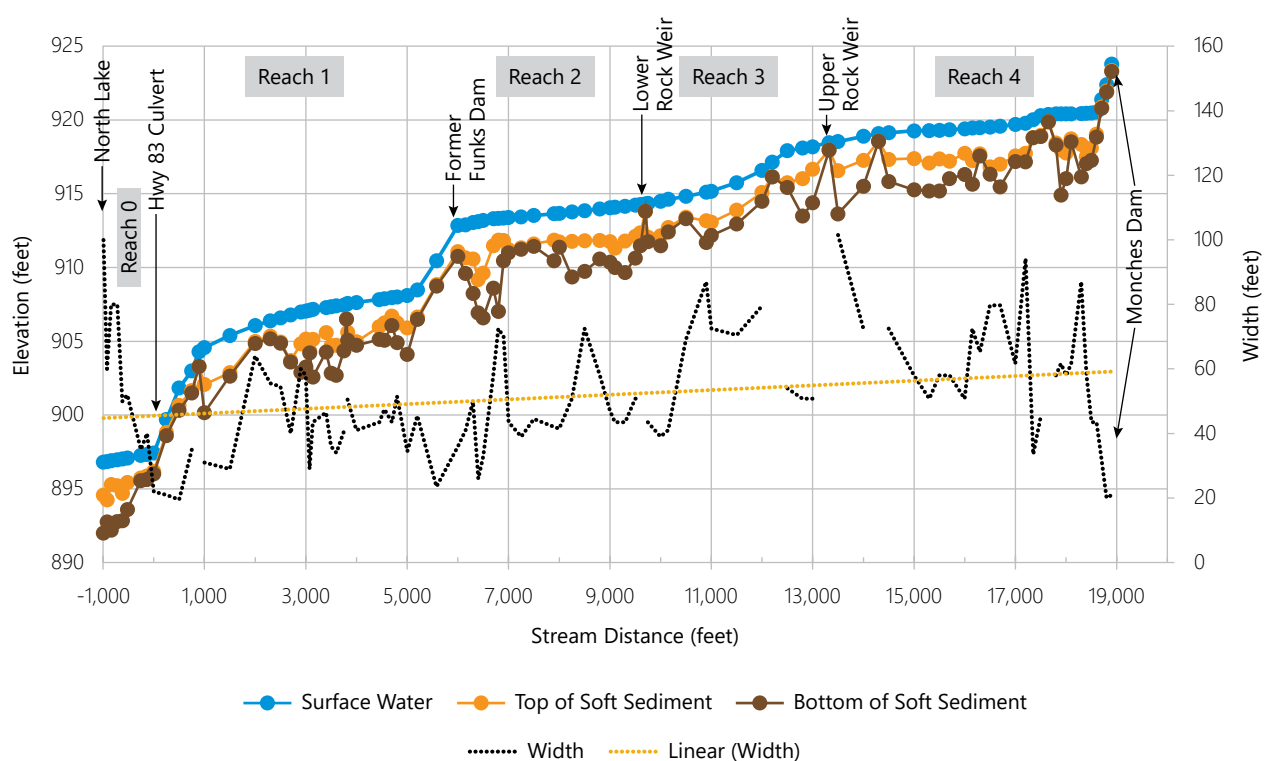
Figure 2.2
Elevation Profile of Surface Water and Soft Sediment Depth Versus Stream
Width from North Lake (-1,000 feet) to Hwy 83 (0.0 feet) to Monches Dam
(19,000 feet) on the Upper Oconomowoc River: October 2018

Ninety-four transects were completed during the 2018 survey. Resultant stream width, water depth, and slope data are summarized by reach in Table 2.1. Figure 2.2 displays the elevation profile of the River’s open water surface, soft sediment bed elevation, hard bottom elevation, as well as stream width from North Lake to Monches dam. It should be noted that the River’s flow seemed to be about one-half foot above normal low-flow conditions during the time of this stream survey. Overall, water depths averaged about 2.0 feet from upstream to downstream, and the deepest pool of 4.9 feet was observed to be in Reach 2 within the former Funk’s dam impoundment. However, good pool depths near to or exceeding three feet were also observed in each of the other reaches (see Figure 2.3). Water widths decrease from an average of about 60 feet upstream in Reaches 3 and 4 to slightly more than 40 feet in Reach 1, and then widths increase back to a mean of 57 feet within Reach 0 downstream of Hwy 83, likely on account of the backwater effect of North Lake. Water widths vary significantly throughout the length of this River, both within and among each study

reach (see Table 2.1) due to several rock weirs and other obstructions that create backwatered areas (see Figure 2.3). These obstructions that include rock weirs, former dam remnants (i.e., mill dam and Funk's dam), an abandoned roadbed, a ford, and bridges affect the slope, water depth, and soft sediment depths and are found throughout the length of this River as shown in Figure 2.2.

percent contain the greater mean and/or maximum sediment depths and the reaches with higher slopes (Reaches 1 and 3) contain lower depths of sediment. However, as noted above, multiple obstructions increase water and sediment depth conditions that can be seen throughout the elevational profile of this River (Figure 2.2).

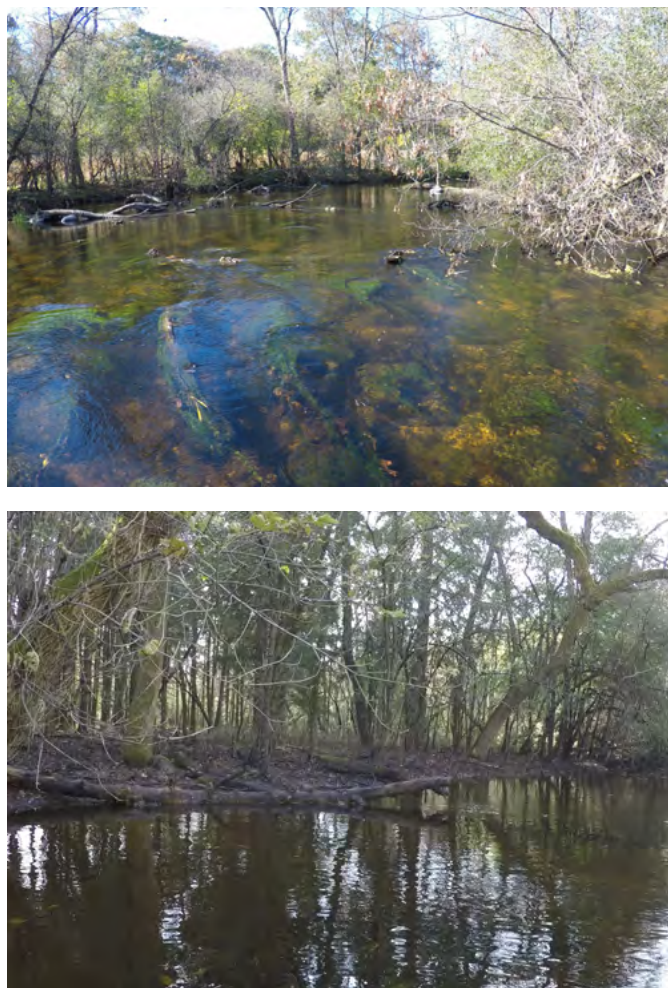
Figure 2.5

Examples of Stable Streambank with Well Vegetated Forest Riparian Buffer and Connected Floodplain Within the Upper Oconomowoc River: October 2018

Commission staff did not observe any failed or excessively eroding streambanks in this 3.6 mile stretch of the River immediately upstream of State Highway 83 to Monches dam during the 2018 on-the-water survey. In addition, comparing aerial imagery from 1995 to 2015 also verified no discernable change in streambank position or stream width over this 20-year time period. The Oconomowoc River in this reach is also protected by an extensive vegetated (mostly forested) riparian buffer that helps to stabilize and protect the streambanks from erosion as well as filter pollutants from runoff before discharging to the River (Figure 2.5). Furthermore, this riparian buffer floodplain is well connected to the River, allowing high flows to spread beyond the streambank and into the vegetated floodplain. This greatly reduces water velocities and erosive forces on the streambanks and promotes sediments to deposit onto floodplain benches, a situation that helps protect streambanks from erosion and improves water quality. Therefore, streambank erosion along this reach is not a likely significant source of sediment transported into North Lake and is not likely affecting the changes in sediment distribution within this portion of the River as summarized in the following text.

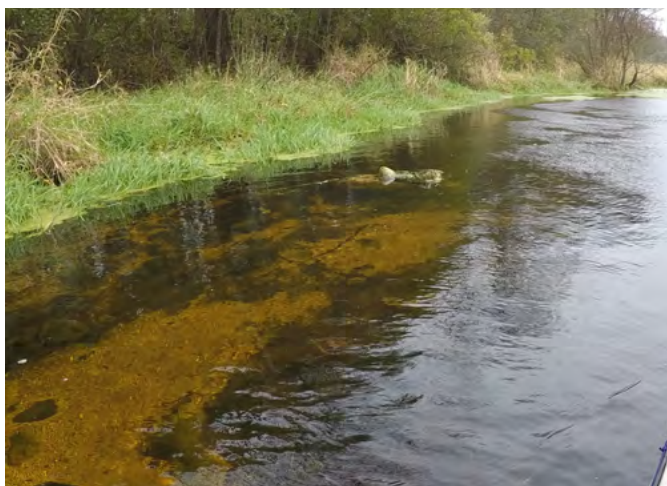
Figure 2.8
Example of Recently Exposed Patch of Gravel
and Cobble Substrate Adjacent to Soft Sediment
Deposition Areas Within Reach 3 of the
Upper Oconomowoc River: October 2018

shown to be reduced (Figure 2.6), sediments are also being transported out of these areas as well, but it is taking more time. For example, Commission staff did observe many areas along channel margins with woody structure combined with exposed large gravel, cobble, and boulder substrates that did not contain any soft sediments, which indicates these areas are recovering. It is also important to note that the large woody structure existing throughout the River is an important habitat feature critical to fish and other wildlife and is indicative of a healthy and functional River system.

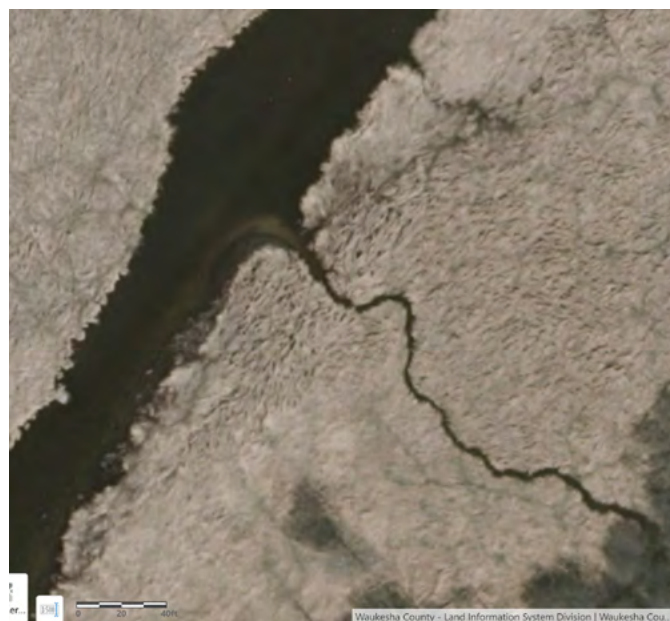
Figure 2.9
Lake Keesus Tributary Confluence with the
Upper Oconomowoc River: 2010 Aerial

A significant amount of sediment was observed to be within and just downstream of the Lake Keesus Tributary confluence with the Upper Oconomowoc River within Reach 2 at about 8,250 feet. This sediment forms a delta within the River that can be seen in aerial photographs when conditions are right (see Figure 2.9). This sediment consists of silt mixed with sand, which is why it appears lighter in color on the riverbed (see Figures 2.9 and 2.10). As shown in Figure 2.10, the thickest soft-sediment deposit within the Upper Oconomowoc River is found downstream of the confluence with the Lake Keesus Tributary where soft sediment depths approach nearly three feet. These deposits are also undoubtedly being transported downstream. The organic silts likely emanate from sources upstream of CTH E and the sands are likely coming from downstream of CTH E (see Chapter 3, "Approaches to Reduce Pollutant Loading", for more details). As shown in Figure 2.11, the Lake Keesus Tributary above CTH E to the outlet of Lake Keesus (roughly 6,100 feet) sits on a relatively flat plateau and has an overall slope of less than 0.1 percent or about 4.3 feet per mile. This section of the Tributary is ditched through wetlands and adjacent agricultural land drains to it, making it a likely source of organic sediments. In contrast, below CTH E to the confluence of the River (roughly 1,050 feet), the Tributary drops 32 feet and has a slope greater than three percent or more than 160 feet per mile. This high sloping portion of the Tributary is more indicative of a "ravine stream" that has great potential to transport larger sized substrates, which is why its bed is mostly comprised of larger gravel, cobble, and boulder substrates (see Figure 2.12). Hence, this is the likely source of the sand substrates mixed with the silty and darker colored organic substrates being deposited in the Upper Oconomowoc River below the confluence of the Lake Keesus Tributary.

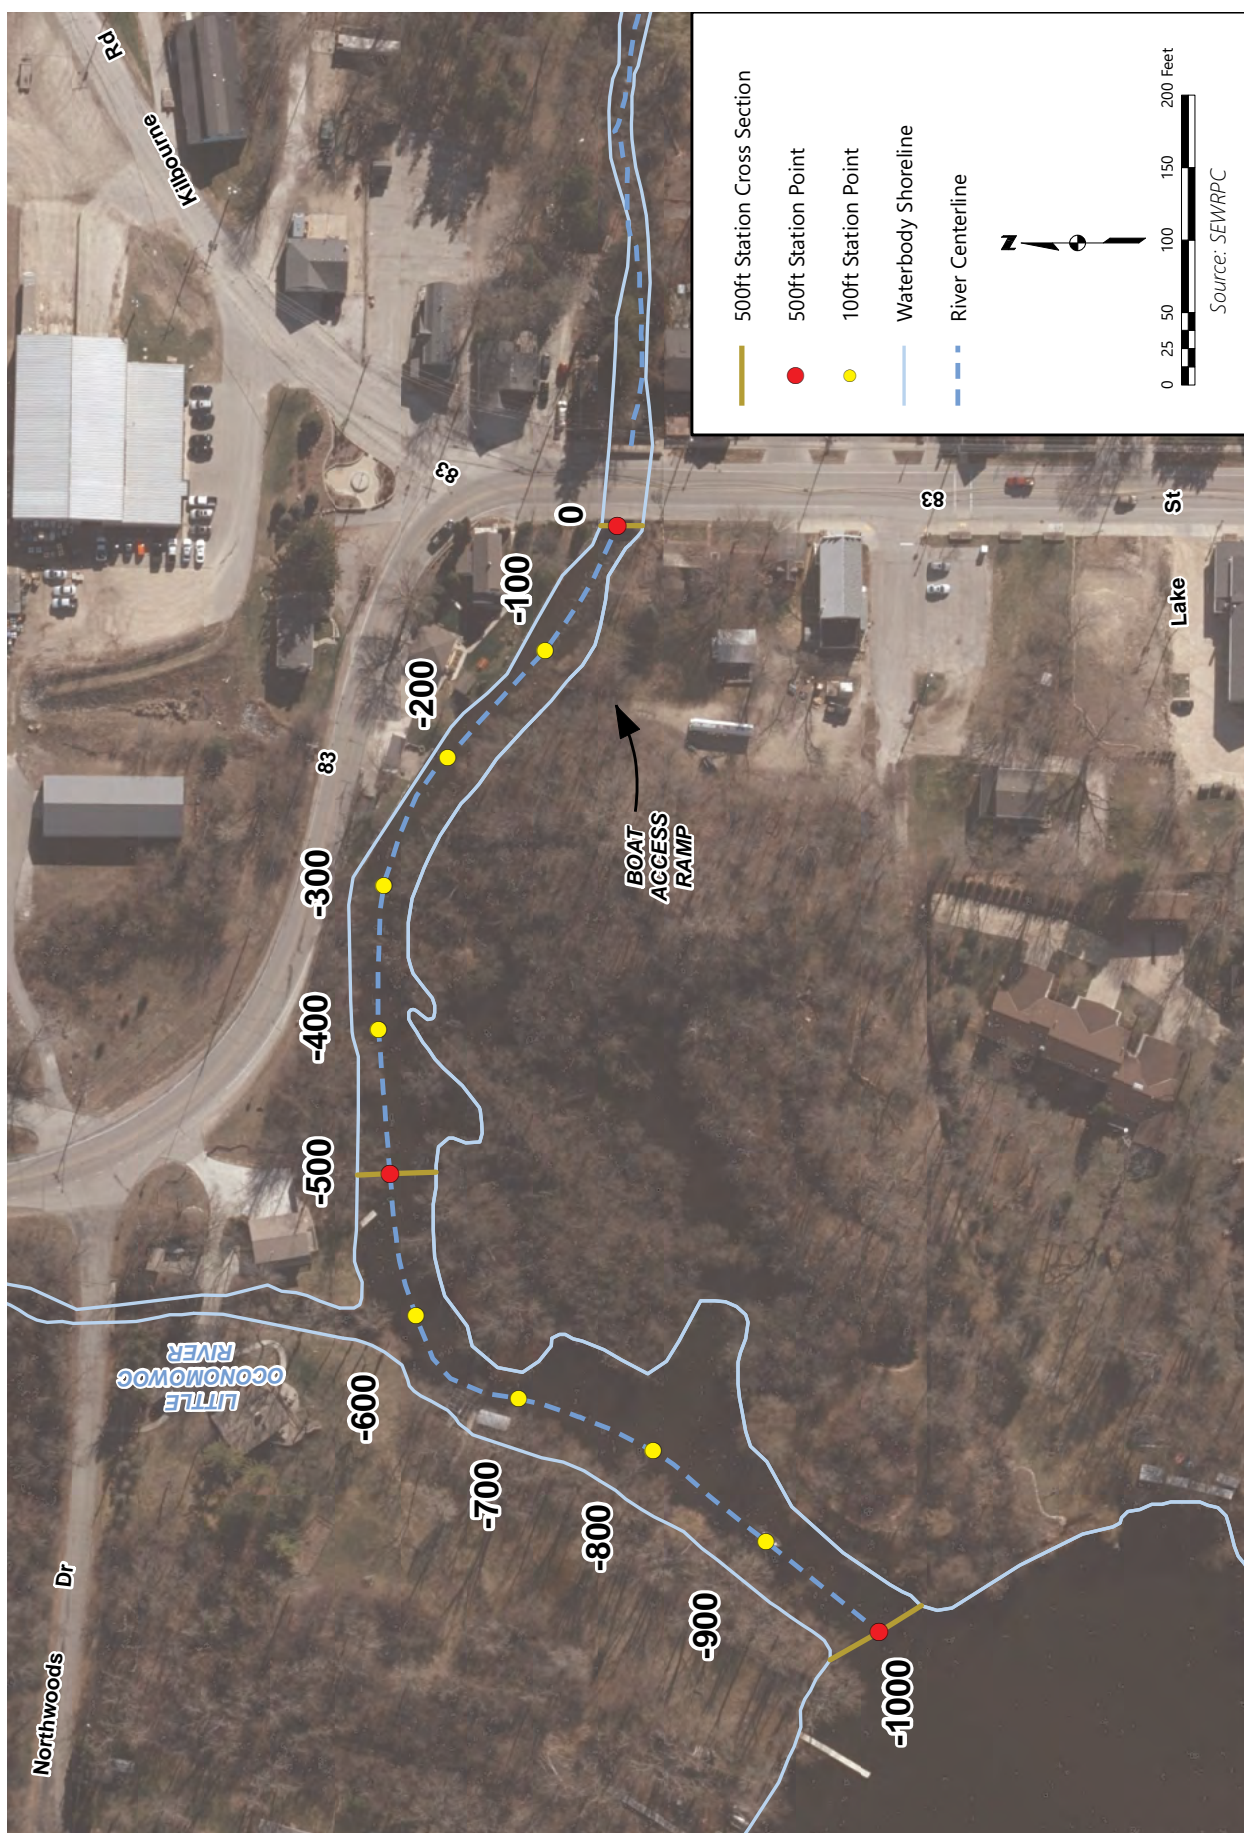
Map 2.8

Upper Oconomowoc River Cross-Section Survey Stationing from Confluence with North Lake (~1000 feet) to Hwy 83 (0.0 feet): October 2018

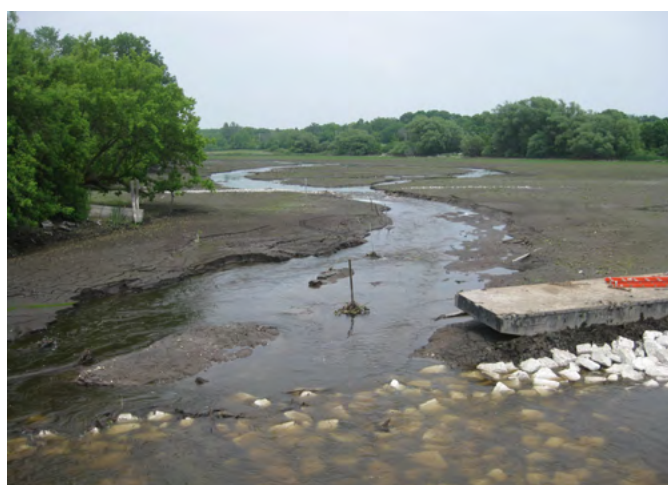
Figure 2.16
Monches Dam Millpond During
Drawdown Condition: June 2013

Note: View looking northeast from CTH E.

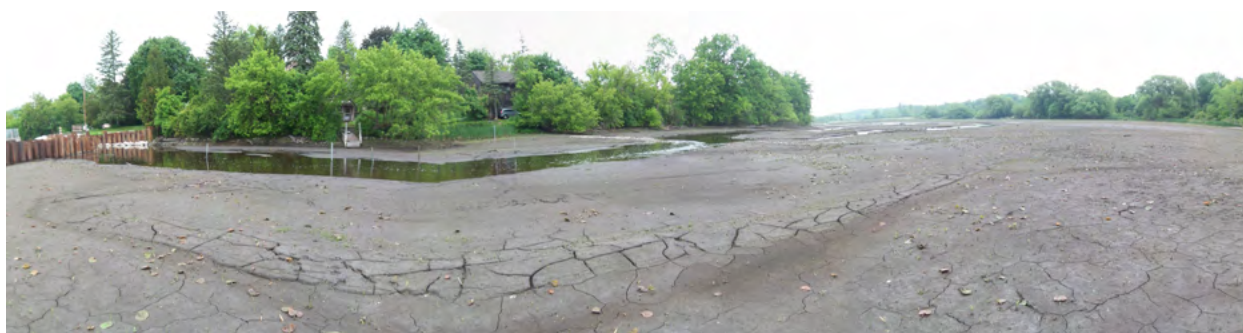
Figure 2.18
Monches Dam Millpond Drawdown Condition: June 2013

Note: Panoramic view/composite of several photos showing the southern outlet (left) under construction and entire basin to the northeast (right).

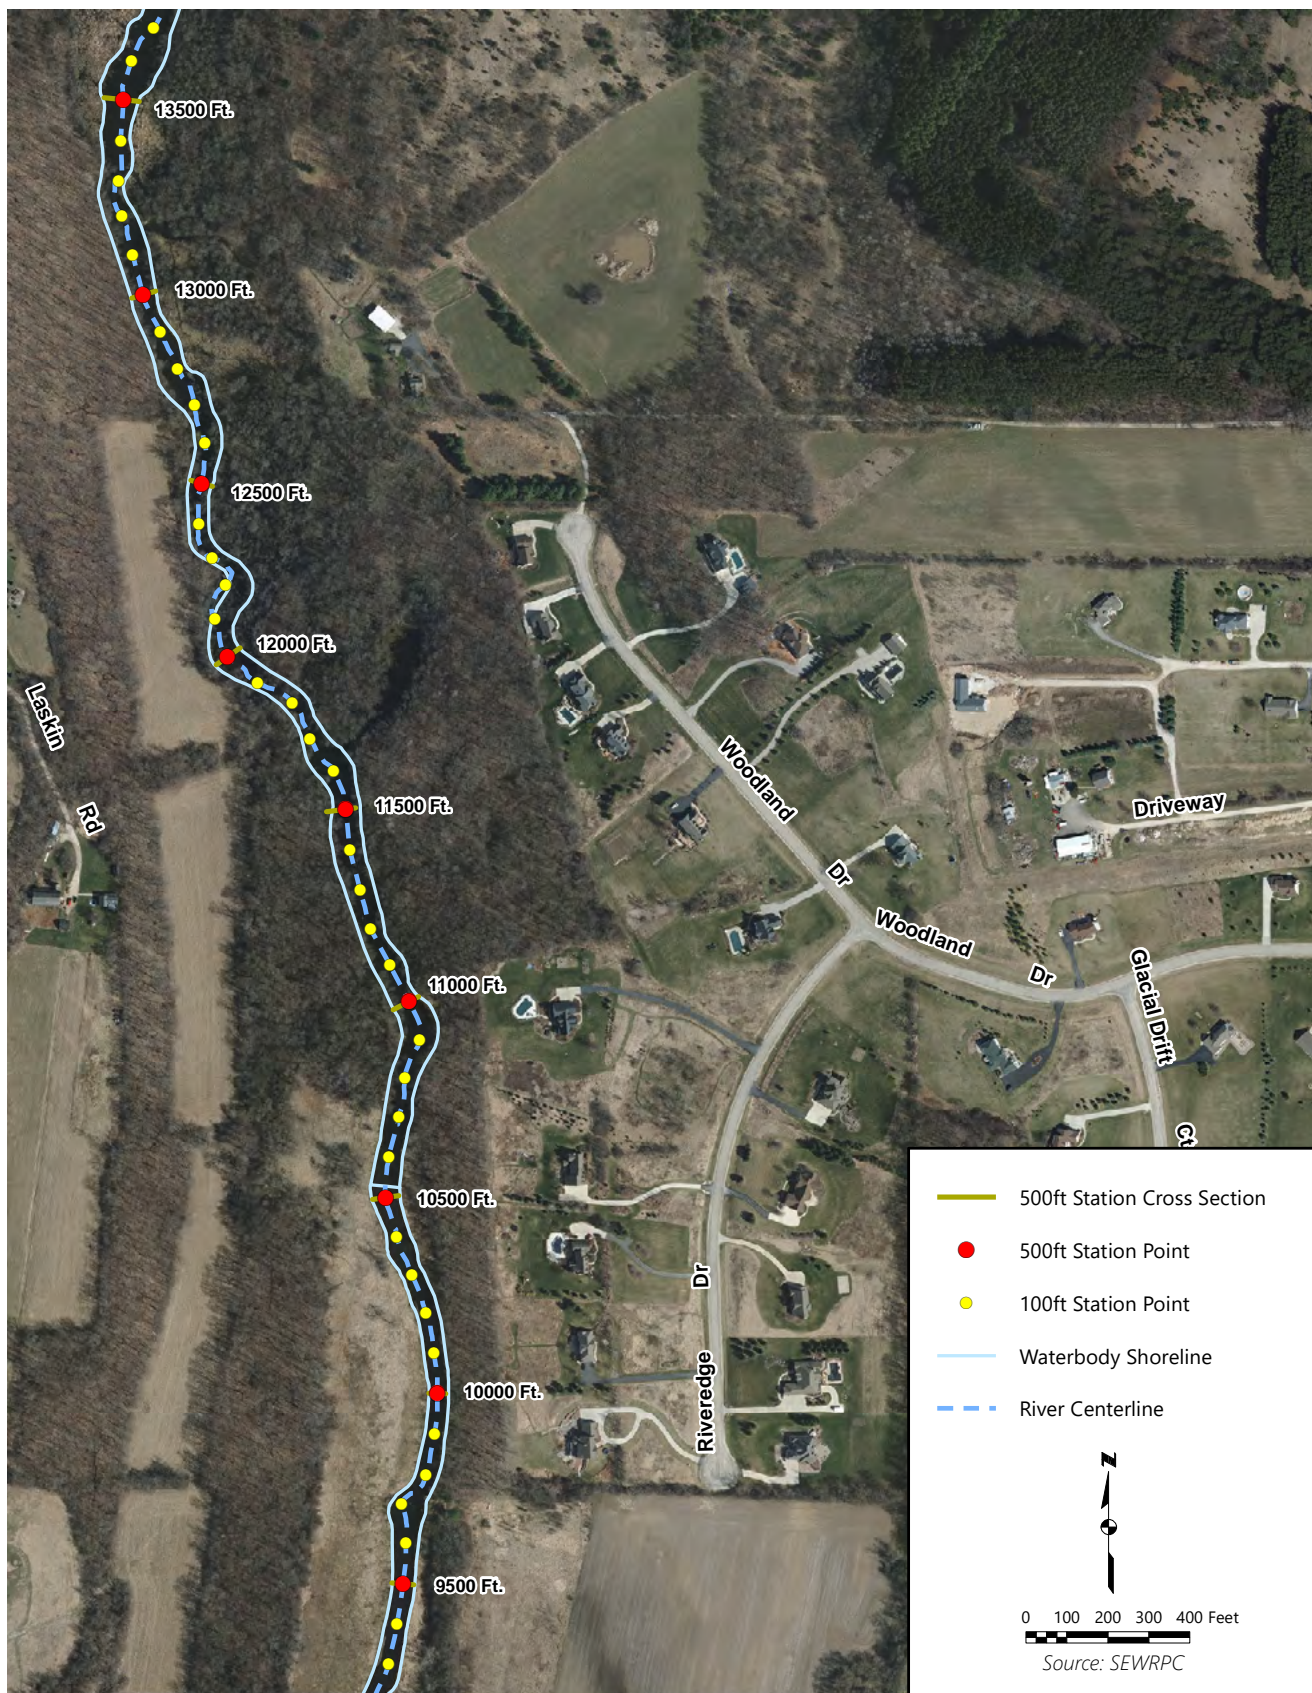
Map A.3
Upper Oconomowoc River Cross-Section Survey Stationing from
9,500 Feet to 13,500 Feet: October 17-19, 2018

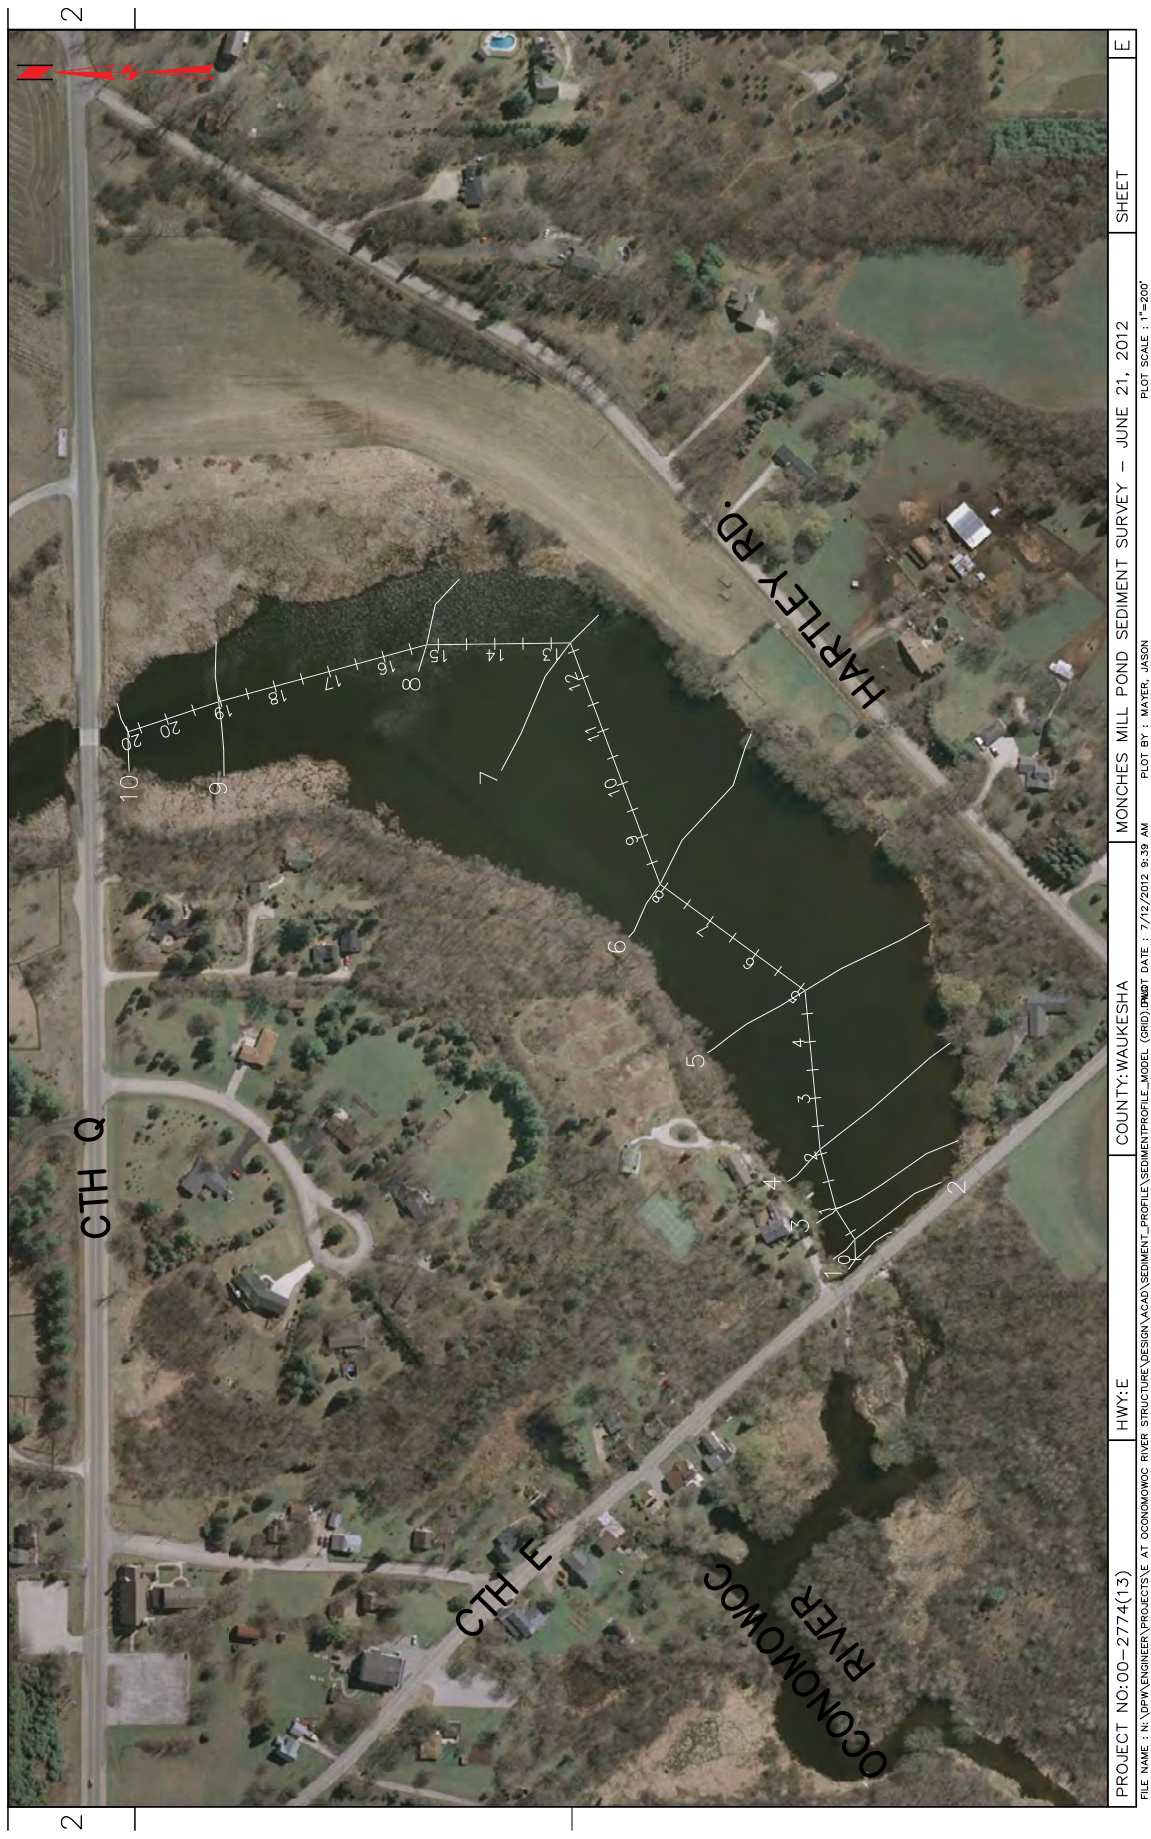
2012 MONCHES DAM MILLPOND SEDIMENT SURVEY⁵⁰

PROJECT NO: 00-2774(13)	HWY: E	COUNTY: WAUKESHA	MONCHES MILL POND SEDIMENT SURVEY - JUNE 21, 2012	SHEET	E
FILE NAME : N:\QDW\ENGINEER\PROJECTS\AT OCONOMOWOC RIVER STRUCTURE\DESIGN\ACAD\SEDIMENT\PROFILE\MODEL (GRID).PNG; DATE : 7/12/2012 9:39 AM PLOT BY : WAYER, JASON PLOT SCALE : 1"=200'

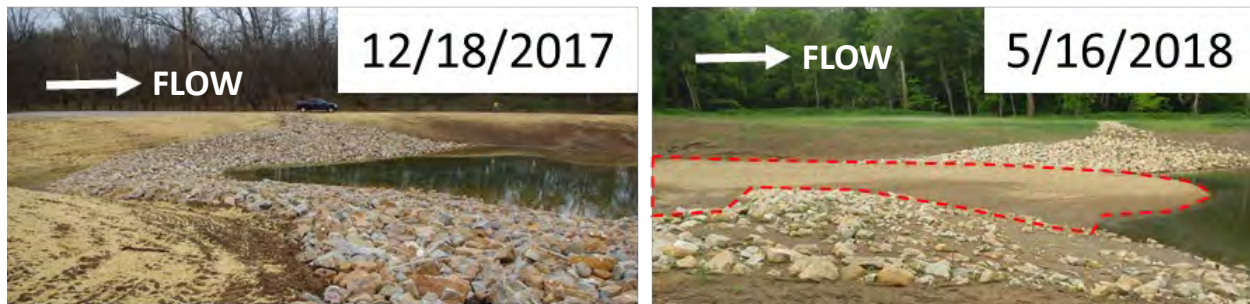
Figure 5. Deposition of coarse sediment at the upstream entrance to trap; during low water (Pics: J.Collum)

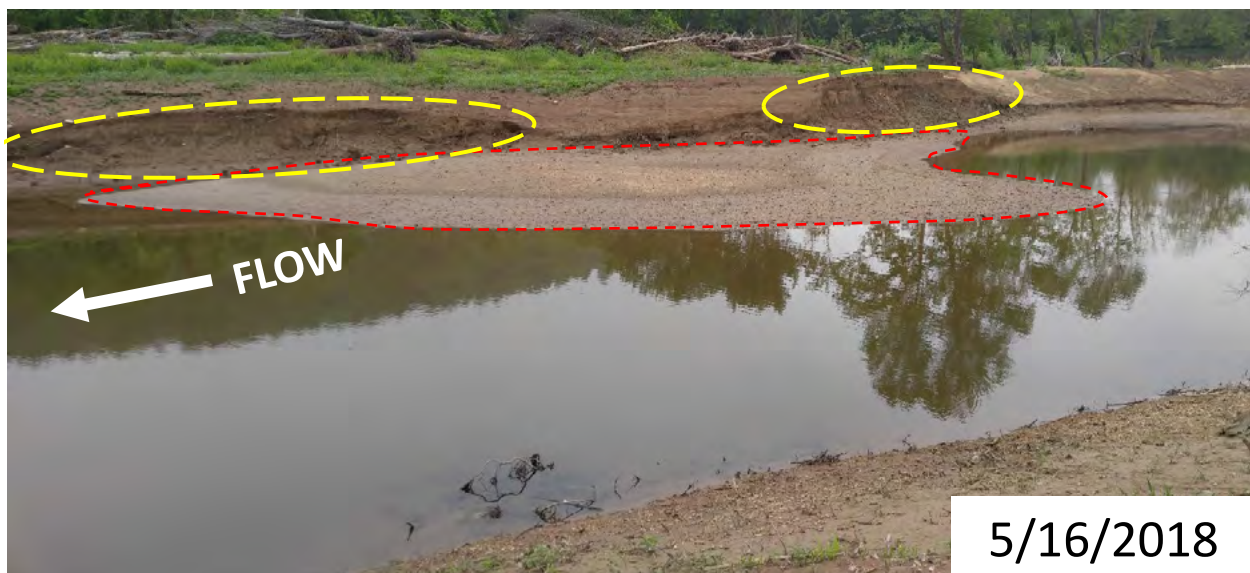
Figure 6. Deposition of fine sediment within trap; during low water (Pic: J.Collum)
