# SOUTHEASTERN WISCONSIN REGIONAL PLANNING COMMISSION

## SEWRPC Staff Memorandum

### PRELIMINARY MORPHOLOGY, WATER LEVEL, WATER QUALITY, AND WAVE PROPAGATION UPDATE FOR NORTH LAKE, TOWN OF MERTON, WAUKESHA COUNTY

March 10, 2021

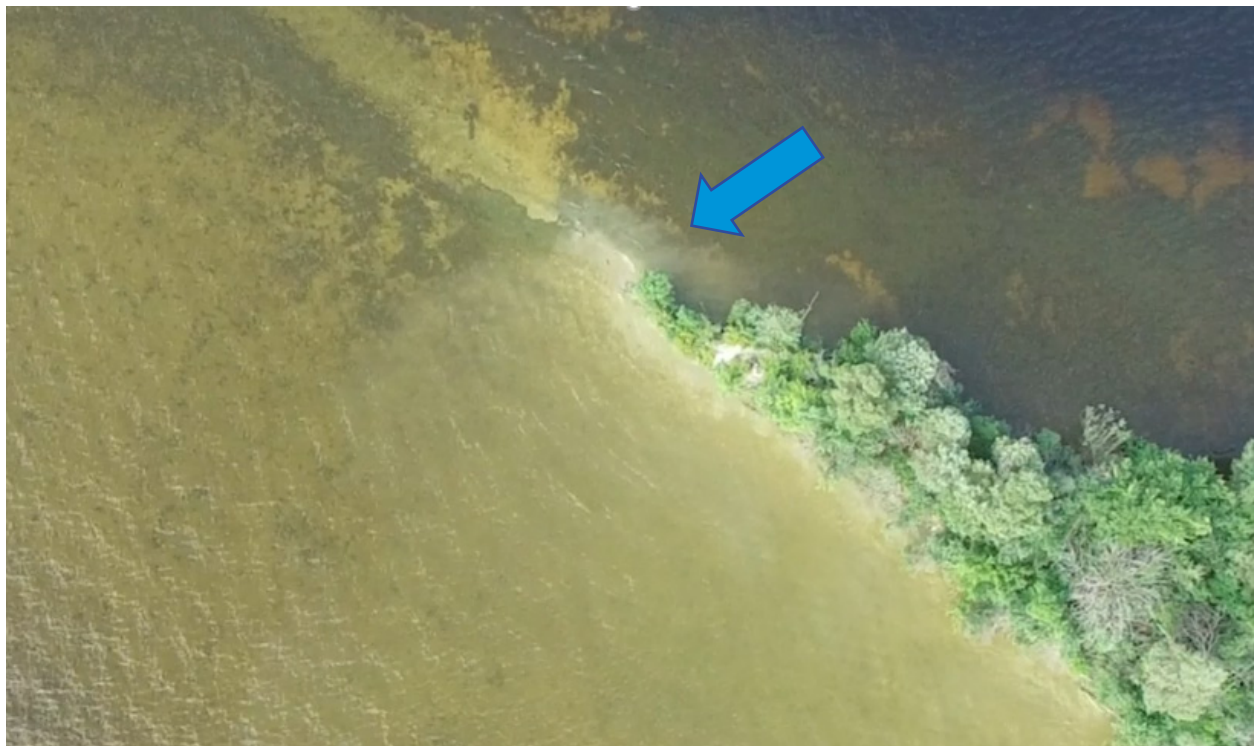
**Figure 2**  
**Unmanned Aerial Vehicle (UAV) Imagery of Sediment Disturbance on North Lake: July 2019**

*Note: The blue arrow indicates the sediment plume coursing around Wildwood Point.*

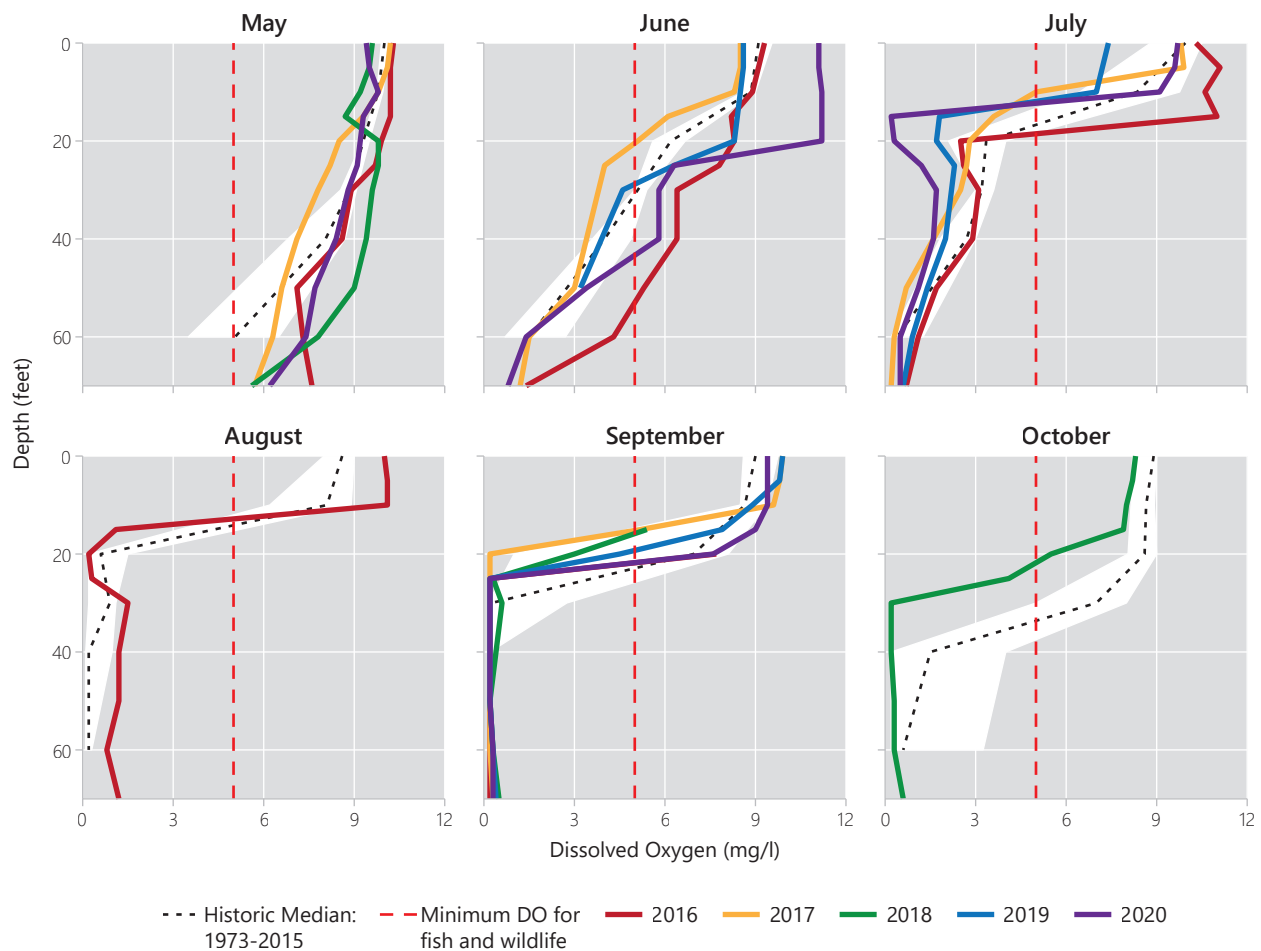
**Figure 7**  
**North Lake Dissolved Oxygen Profiles: 1973-2020**

Note: The white ribbon indicates the lower 25 percent and upper 75 percent quantiles of the historic range.

Temperature and oxygen concentration profiles were assembled from data spanning more than 40 years. These profiles suggest that North Lake stratifies every year and remains stratified throughout the summer (see Figures 6 and 7). The summer thermocline is generally around 10 feet thick and is found somewhere between 10 and 40 feet below the Lake's surface. As summer progresses, the epilimnion thickens and the thermocline is generally found deeper in the Lake. Denser, warmer water occasionally accumulates in the deepest areas of the Lake during winter, producing weak stratification.<sup>16</sup> Recent water temperature profiles (2016 to 2020) indicate that Lake water was within the historical range (1973 to 2015) throughout most of the profile, with surface temperatures occasionally exceeding the historical range. Recent dissolved oxygen profiles are generally within the historical range and indicate that hypoxic (oxygen concentrations below

5 mg/l) conditions persist throughout most of the summer from depths of 20 feet to the lake bottom. These hypoxic conditions are perilous to the health of aquatic organisms, particularly fish, and are generally driven by elevated nutrient concentrations, particularly nitrogen and phosphorus, within the waterbody. However, these conditions have been observed in the Lake since the earliest water quality analyses in 1906, so these may be more reflective of long-term watershed influences than any recent changes in boating activity.<sup>17</sup>
