MASON CREEK WATERSHED PROTECTION PLAN

COMMUNITY ASSISTANCE PLANNING REPORT
NUMBER 321

June 2018

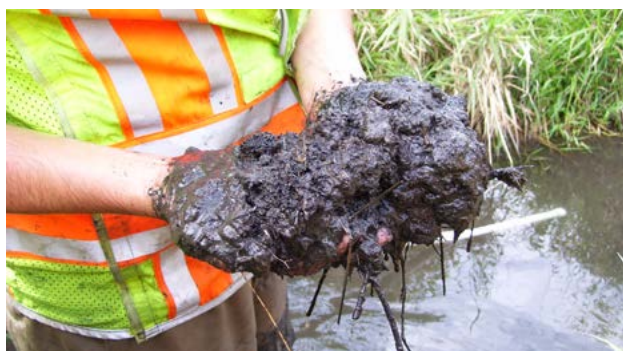
Example of flocculent sediment filling in streambed within the channelized reaches of Mason Creek. September, 2014

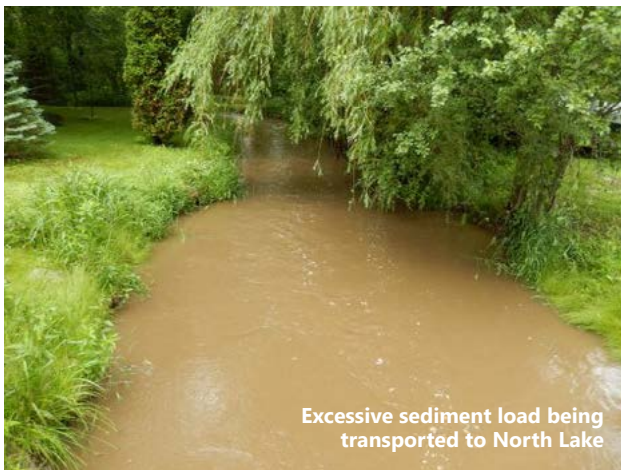
Excessive sediment load being transported to North Lake

Mason Creek (looking upstream, before entering North Lake) after a storm event. July, 2014

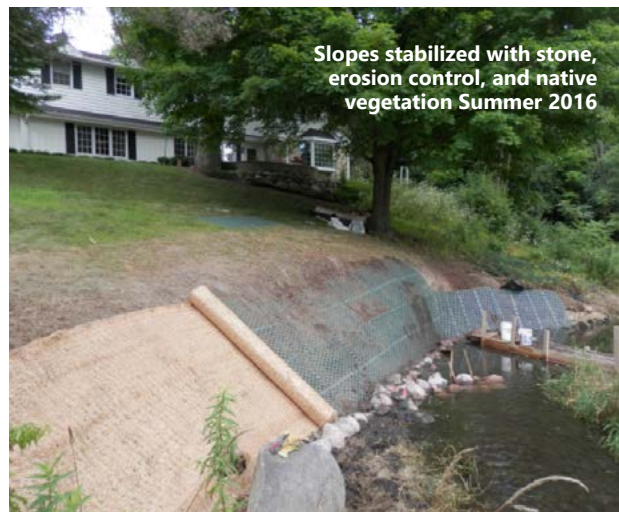
Streambank is being restored to prevent severe erosion within Mason Creek

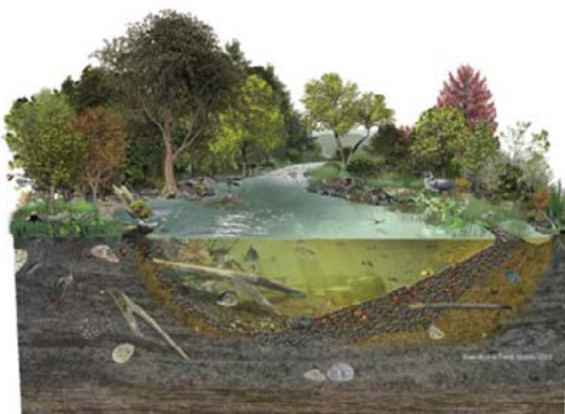
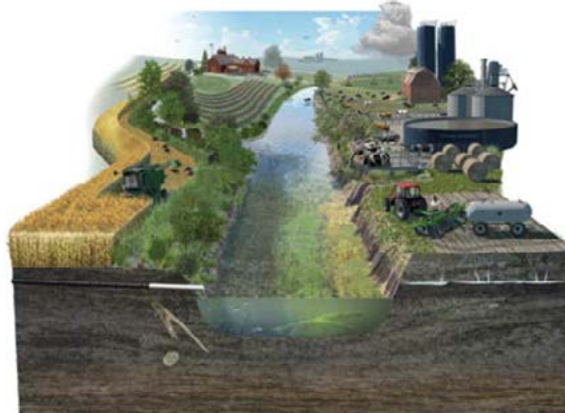
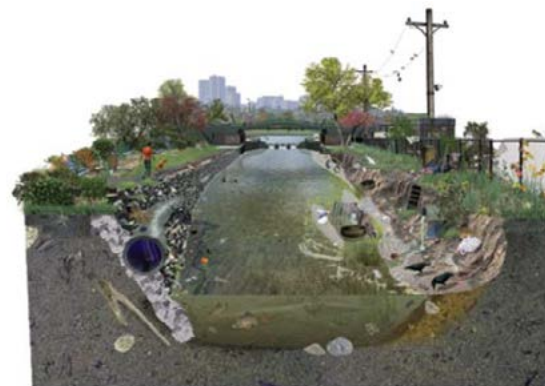
Figure 2.2
Illustrations of the Dynamic
Components of Natural, Agricultural,
and Urban Stream Ecosystems

NATURAL STREAM ECOSYSTEM

AGRICULTURAL STREAM ECOSYSTEM

URBAN STREAM ECOSYSTEM

In general, human activities in agricultural settings alter the natural flow regime of streams and rivers through 1) subsurface drain tiles, which lower the water table and quickly route water to nearby streams; 2) ditching and straightening of headwater streams; and 3) irrigation, which supplements available water for crops. These changes can result in more rapid runoff, reduced streamflows during dry periods, and increased transport of sediments and pollutants. However, since there is a diversity of agricultural practices (see Figure 2.2, Agricultural Stream Ecosystem), the impacts to stream ecosystems can be highly variable.

In an urban setting, human activities change the movement of water in a watershed through introduction of increased impervious surfaces, such as buildings and pavement for roadways and parking, which restrict the infiltration of precipitation into the groundwater system, combined with construction of artificial drainage systems (e.g., storm sewer systems) that quickly move runoff to streams (see Figure 2.2, Urban Stream Ecosystem). These impervious surfaces can lead to increased stormwater runoff and higher and more variable peak streamflows (see Figure 2.3), which scour the streambed or banks and degrade the stream channel. Reduced infiltration to groundwater can lead to diminished streamflows during dry periods, particularly in stream systems where groundwater is the main source of base flow. In addition, in urban areas with a groundwater supply serving residential, industrial, and commercial land uses, increases in the withdrawal of groundwater can also affect the natural flow regime of stream systems.

Human activities often contribute additional amounts of these naturally occurring substances, as well as other synthetic (manmade) chemicals, to streams from point and nonpoint sources. Runoff from agricultural lands (see Agricultural Stream Ecosystem in Figure 2.2) may contain 1) sediment from soil erosion on tilled lands; 2) nutrients from the application of fertilizer and manure; and 3) pesticides used in the past and present to control insects, weeds, rodents, bacteria, or other unwanted organisms. Runoff from urban lands (see Urban Stream Ecosystem in Figure 2.2) may contain 1) sediment from construction activities; 2) nutrients and pesticides applied to lawns and recreational areas; and 3) petroleum compounds, trace metals, and deicing salts from roads and parking lots. Point sources include municipal and industrial wastewater effluent that, depending on the sources of wastewater and level of treatment, may contain different amounts of nutrients and other contaminants.

Land uses that affect streamflow, sediment availability, or riparian vegetation alter physical habitats in streams. Some agricultural practices (see Agricultural Stream Ecosystem in Figure 2.2), such as conventional tillage near streambanks and drainage modifications, lead to increased sediment erosion, channelization, or removal of riparian vegetation. Increased sediment from erosion can fill crevices between rocks and cobble in the streambed, which reduces living space for many stream organisms. As watersheds urbanize (see Urban Stream Ecosystem in Figure 2.2), some segments of streams may be cleared, ditched, straightened, and enclosed to facilitate drainage and the movement of floodwaters. These modifications increase stream velocity during storms, which can transport large amounts of sediment, scour stream channels, and remove woody debris and other natural structures that provide habitats for stream organisms. In addition, culverts and ditches can be barriers to aquatic organisms that need to migrate throughout the stream network. Humans can alter natural stream temperature through changes in the amount and density of the canopy provided by riparian trees. In some extreme cases, streams in urban areas are routed through pipes and completely buried.

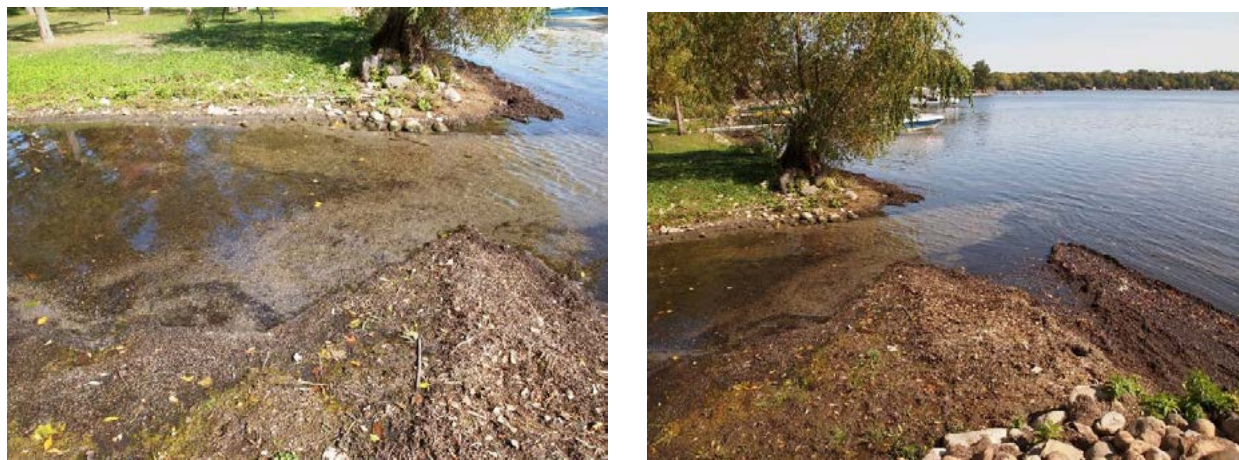
LOW FLOW CONDITIONS- LOW SUSPENDED SEDIMENTS IN WATER ON SEPTEMBER 25, 2012

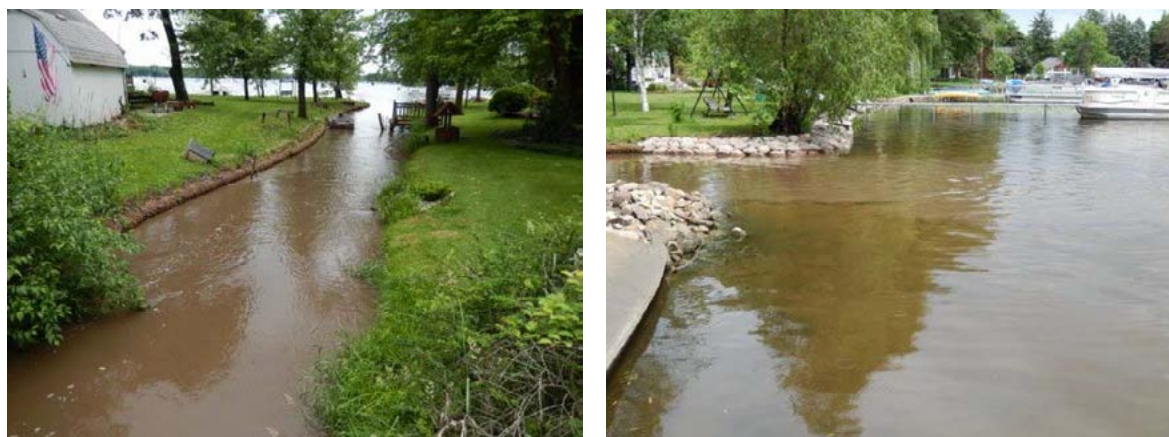
HIGH FLOW CONDITIONS-HIGH SUSPENDED SEDIMENTS DISCHARGING AFTER RAINFALL EVENT ON JULY 22, 2014

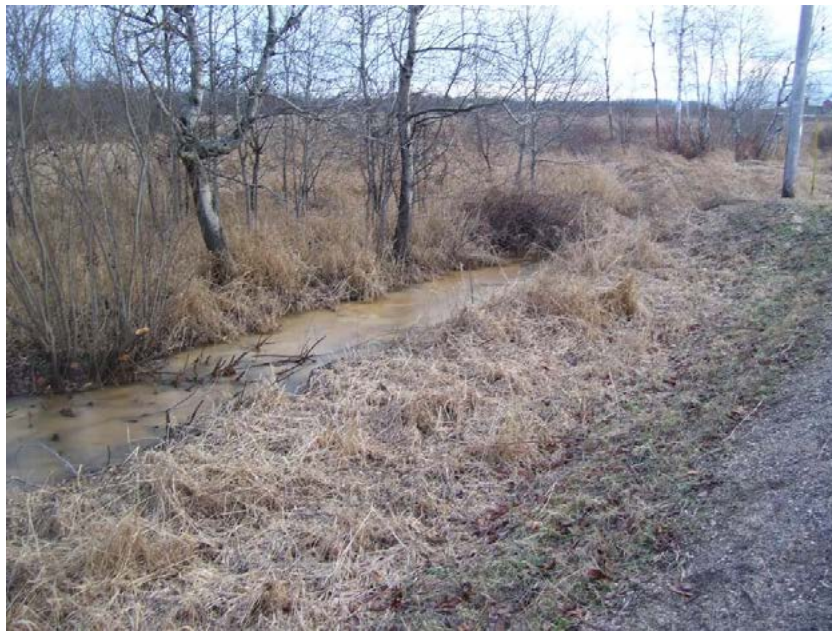
Gully #7 Along Erin Road

Figure 2.20
High Suspended Sediment Loads in Gully Number 7 and Concentrated
Flow Coming off an Agricultural Field – December 19, 2014

Mason Creek has a very high amount of nutrients and suspended solids in the water. A visual assessment of Mason Creek during a peak storm or runoff event clearly shows high amounts of sediment being carried as seen in both upstream areas (Figure 2.20) and downstream areas (Figure 2.16). Periodic algae blooms are also common during the summer months, particularly in the lowest reach just upstream of North Lake. Although the data are somewhat limited by the number of samples, it is apparent that the highest concentrations in suspended solids, total phosphorus, and nitrogen are associated with the greater discharges in Mason Creek, so the highest amounts of pollutant loading occurs during higher flow events. This indicates that a significant amount of the pollutants can be attributed to runoff.

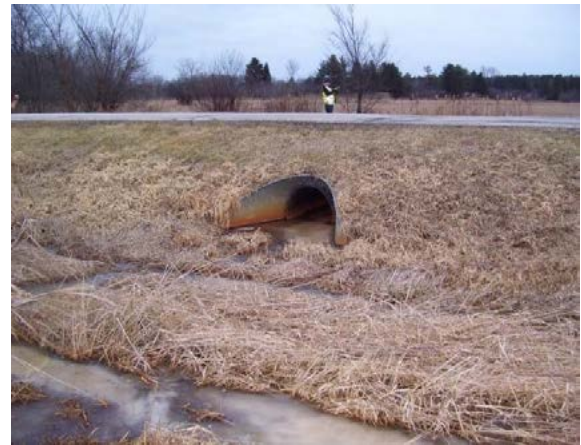
Concentrated Flow Entering Culvert Leading to Gully #7

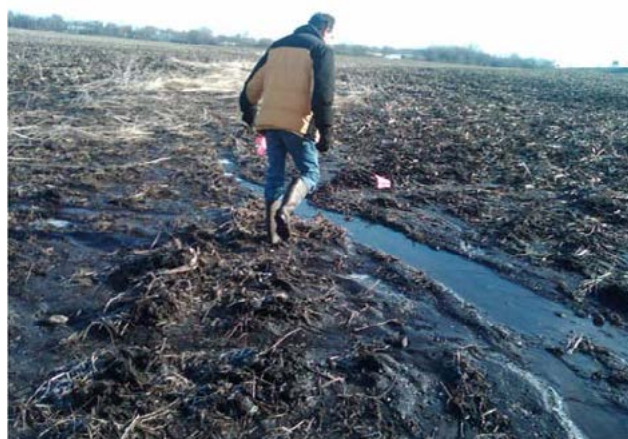
LOW RESIDUE WITH EROSION AND CONCENTRATED FLOW

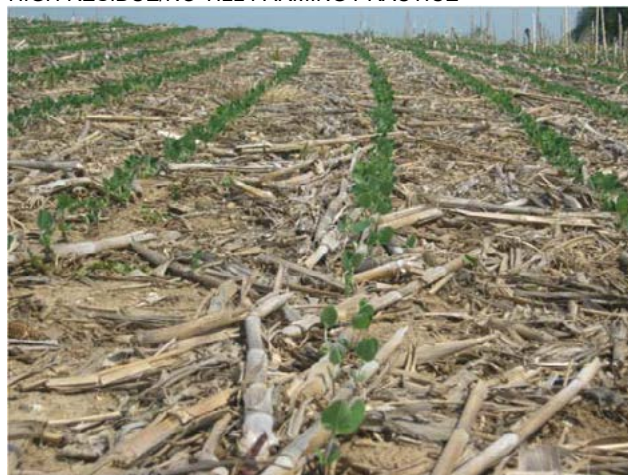
HIGH RESIDUE/NO TILL FARMING PRACTICE

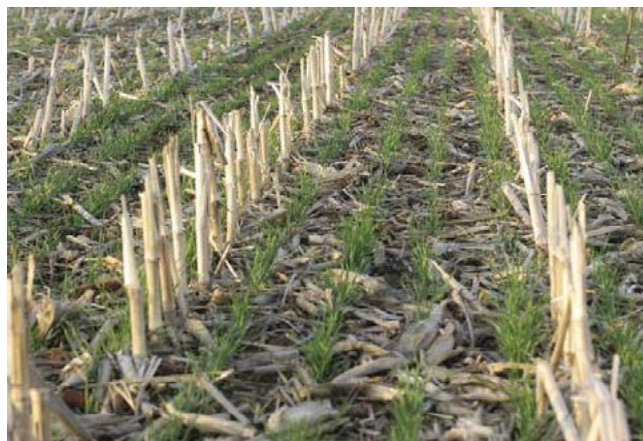
Figure 2.25 One Example of Cover Crop Farming Best Management Practice

COVER CROP WINTER WHEAT NO-TILL PLANTED INTO
SHREDDED CORN STALKS

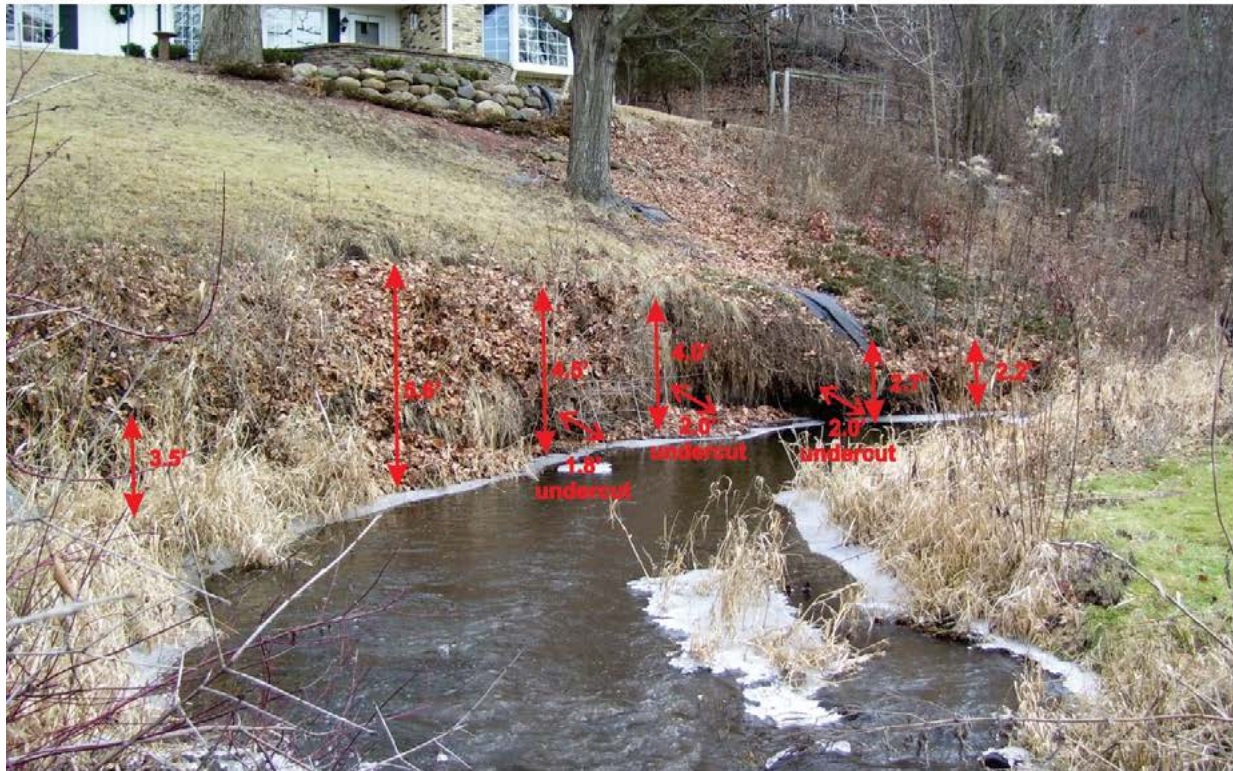
EXISTING CONDITIONS

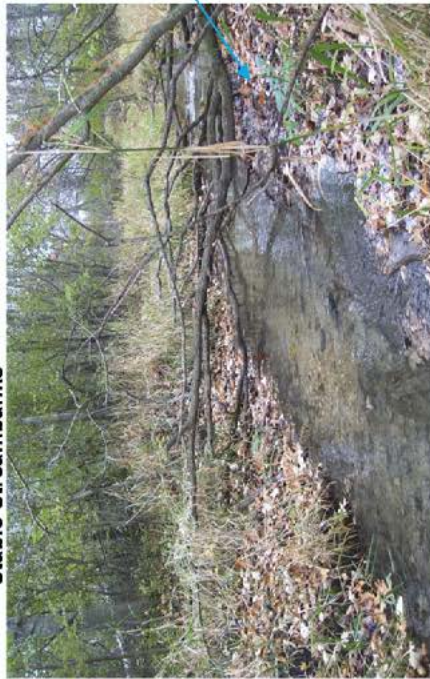
East Branch-Connected Floodplain & Stable Streambanks

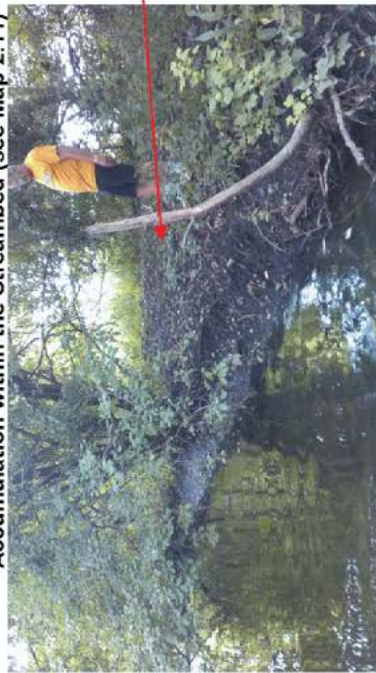
Upper Mason Creek-Disconnected Floodplain & Sediment Accumulation within the Streambed (see Map 2.11)

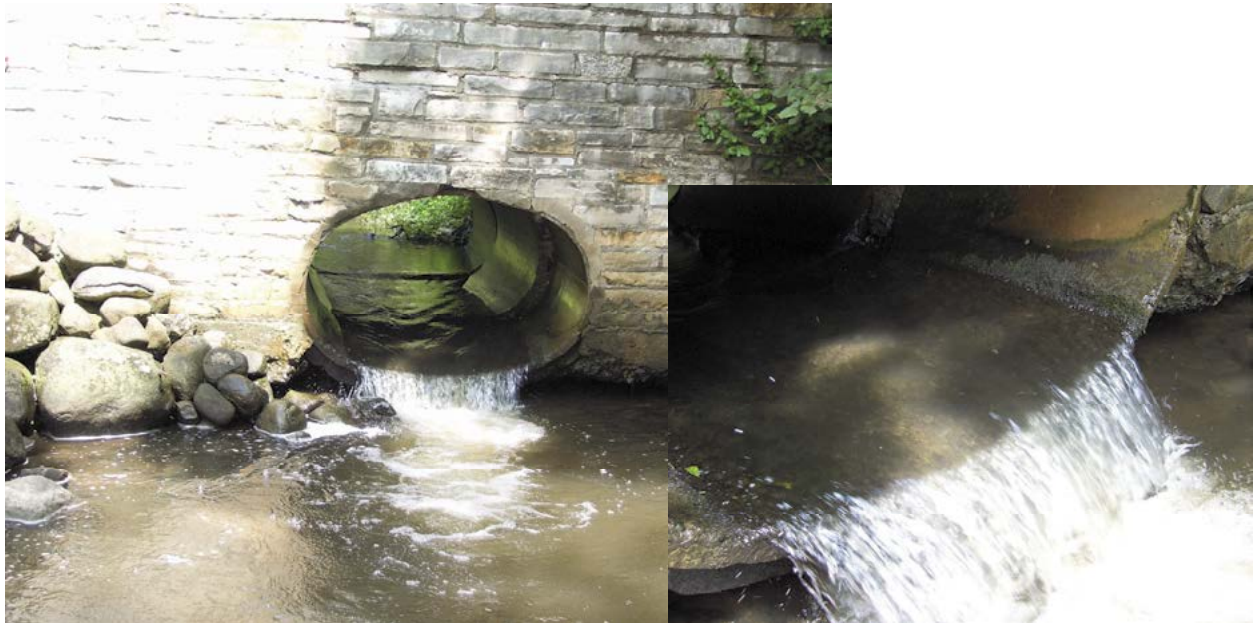
Structure No. 9 at River Mile 0.5—Koester Road,-Complete Barrier

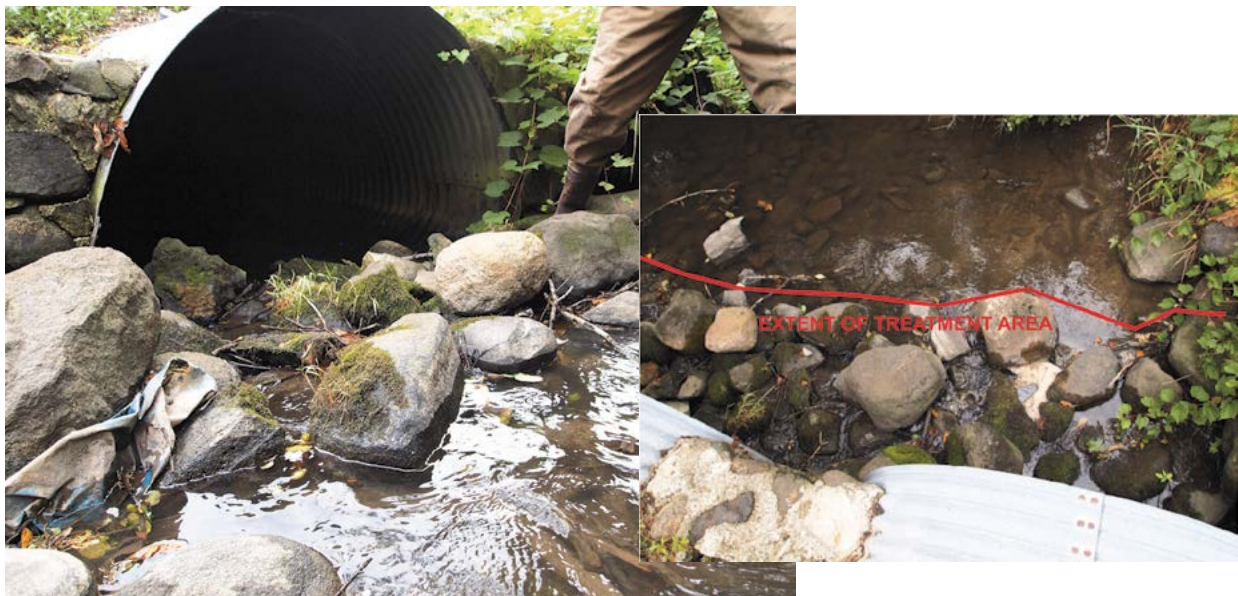
- Excessive amounts of cobble and boulders piled on the upstream side of culverts causing limited fish passage for native fish species for all flows except for high water events due to limited jumping ability and/or behavior

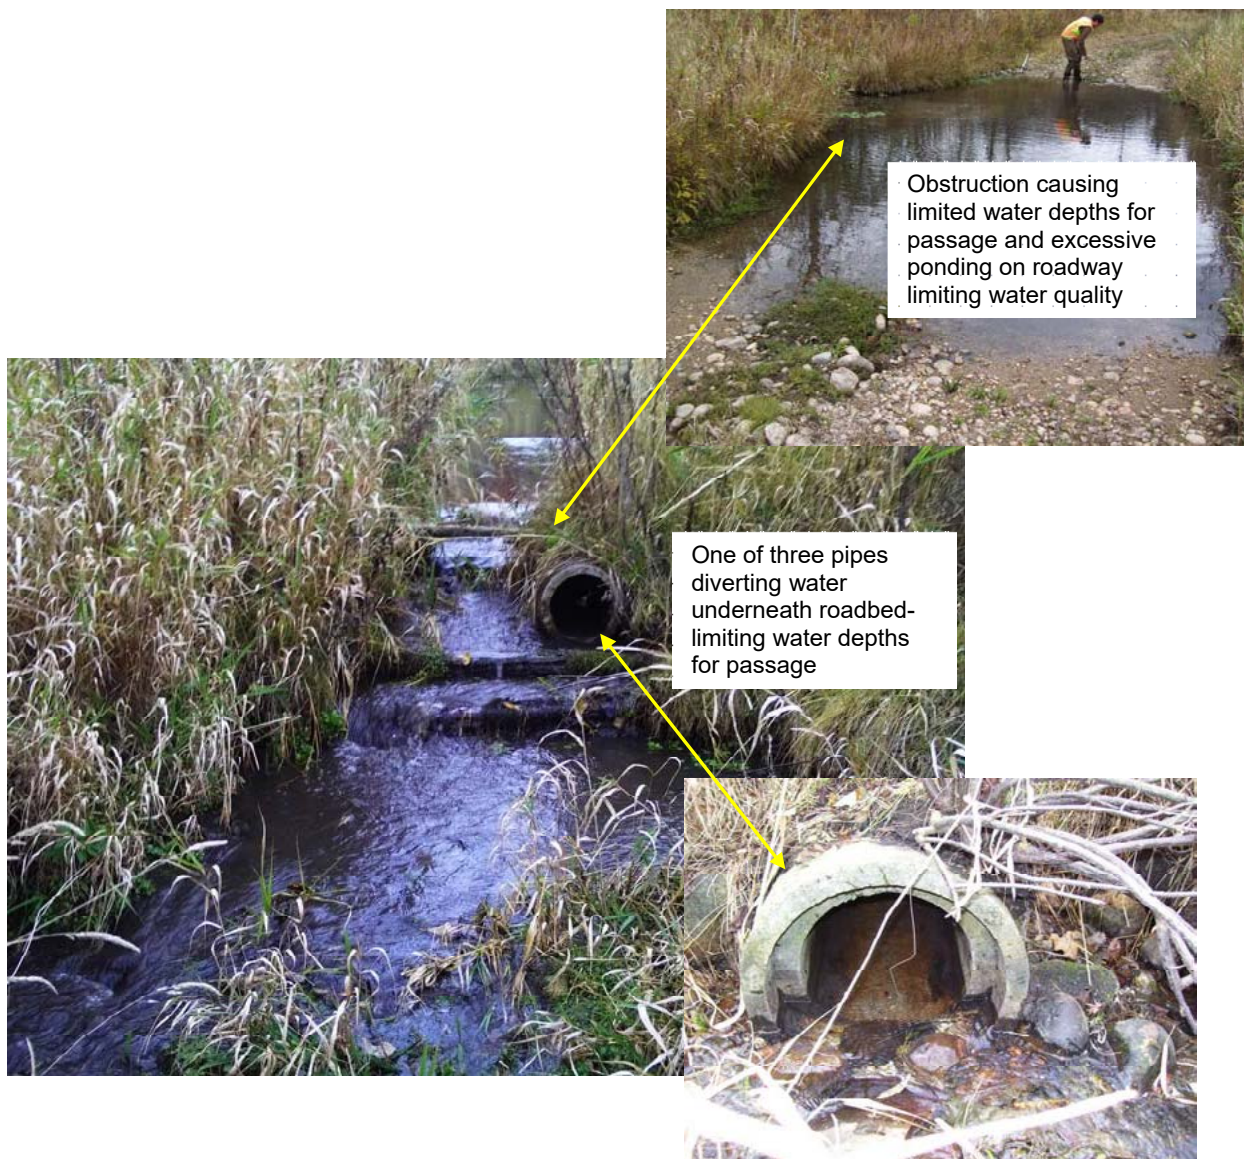
No. 19 at River Mile 0.05 on the East Branch of Mason Creek-Partial Barrier

- Ford at Private driveway contains shallow water depths with obstructions combined with embedded pipes diverting flow are partially limiting fish passage for native brook trout, particularly at low flows, due to limited jumping abilities and/or swimming behavior

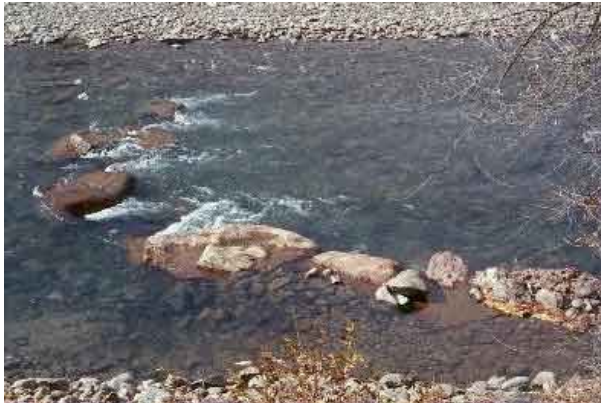
J-Hook Vane

A J-hook vane is an upstream pointing line of rocks that originates at one bank and terminates somewhere in the middle of the stream. The most upstream portion of the structure bends back on itself, like a "J," curving into the middle of the channel. This bent portion serves to concentrate flow and scour out a pool while the length closer to the shore deflects flow away from the bank.

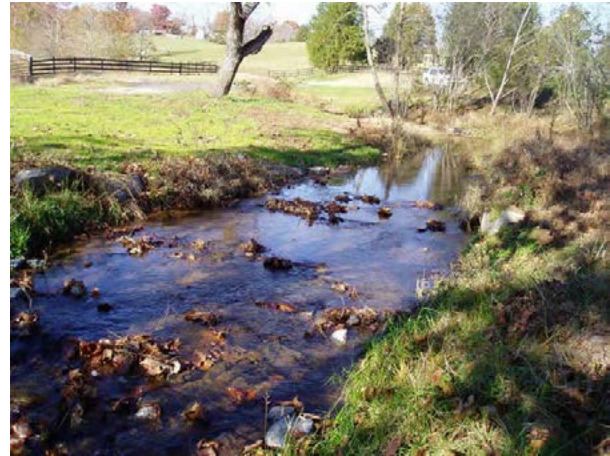
Cross Vanes

Beaver Run Stream Restoration Project Cross-vane Structure-- A cross-vane (2-7% slope) has a vane on each side which covers 1/3 of the bankfull width and the invert portion covers the middle 1/3. They are commonly used for grade-control and to reduce nearbank stress by redirecting flow through the center of the channel. It can also be considered a habitat improvement structure.

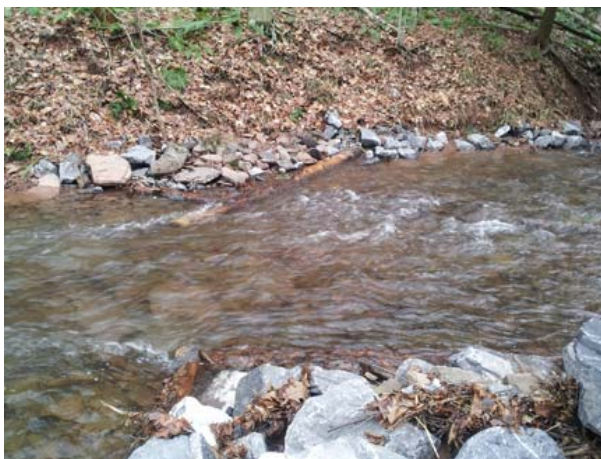
Cross Vane Stream Deflectors within Log Frame

Wallacks Branch Habitat Project
(<http://fortbedfordtu.org/projects/wallacksbranchhabitat.htm>,
bedfordcountyconservation.com)

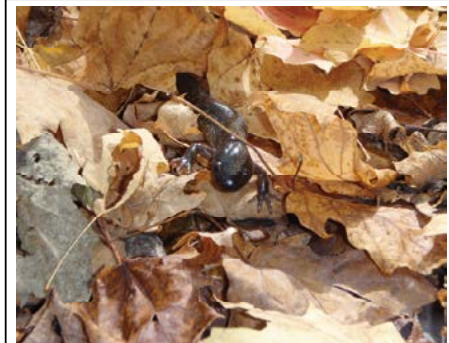
Although *Ambystoma* salamanders require standing water for egg laying and juvenile development, most other times of the year they can be found more than 400 feet from water foraging for food.

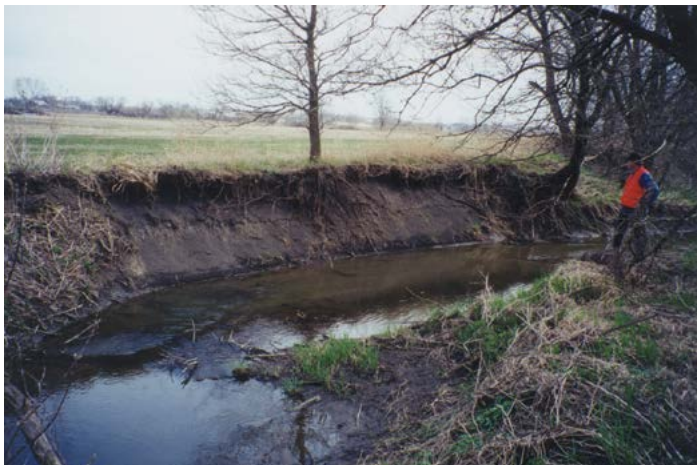
Riparian buffer widths should take into account the amount of area that a stream needs to be able to self-adjust and maintain itself in a state of dynamic equilibrium. ... These are generally greater than any minimum width needed to protect for pollutant removal alone.

Streams are highly sensitive, and they respond to changes in the amounts of water and sediment draining to them, which are affected by changing land use conditions. For example, streams can respond to increased discharges of water by increased scour (erosion) of bed and banks that leads to an increase in stream width and depth—or "degradation." Conversely, streams can respond to increased sedimentation (deposition) that leads to a decrease in channel width and depth—or "aggradation."

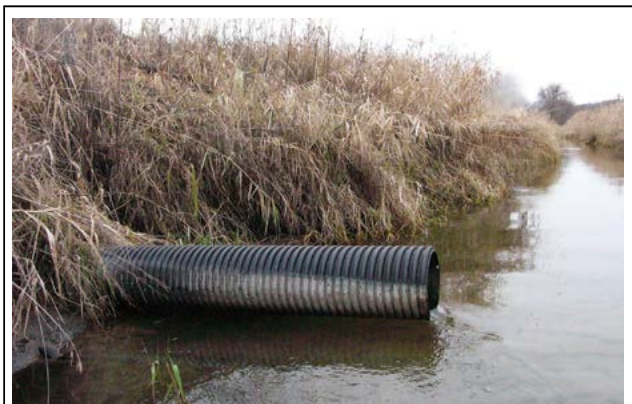
Drain tiles can bypass infiltration and filtration of pollutants by providing a direct pathway to the water and "around" a buffer. This is important to consider in design of a buffer system which integrates with other agricultural practices.

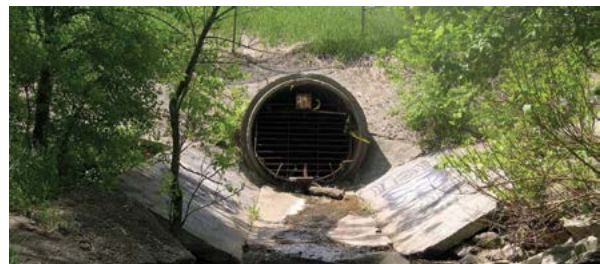
Much traditional stormwater infrastructure intercepts runoff and diverts it directly into creeks and rivers, bypassing any benefits of buffers to infiltrate or filter pollutants. This is important to consider in design of a buffer system for urban waterways, which begin in yards, curbsides, and construction sites, that are figuratively as close to streams as the nearest storm sewer inlet.

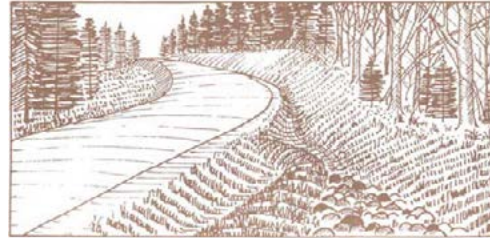
Turnouts return stormwater runoff as sheet flow to natural drainage areas. Often turnouts are simply extensions of ditches that redirect water into the woods and disperse runoff before it can cause erosion. Turnouts reduce the speed of runoff, allowing soil particles to settle out instead of being transported to a stream, river, or lake. Water and nutrients can then be filtered and absorbed by the surrounding vegetation.

Installation: Turnouts are used to direct water away from the road into a vegetated buffer area, and can be constructed on paved or gravel roads with or without ditches. Turnouts can be the width of a backhoe bucket, a bulldozer blade, or a handheld shovel. Turnouts should intersect the ditch at the same depth, and gently slope down and away from the road.

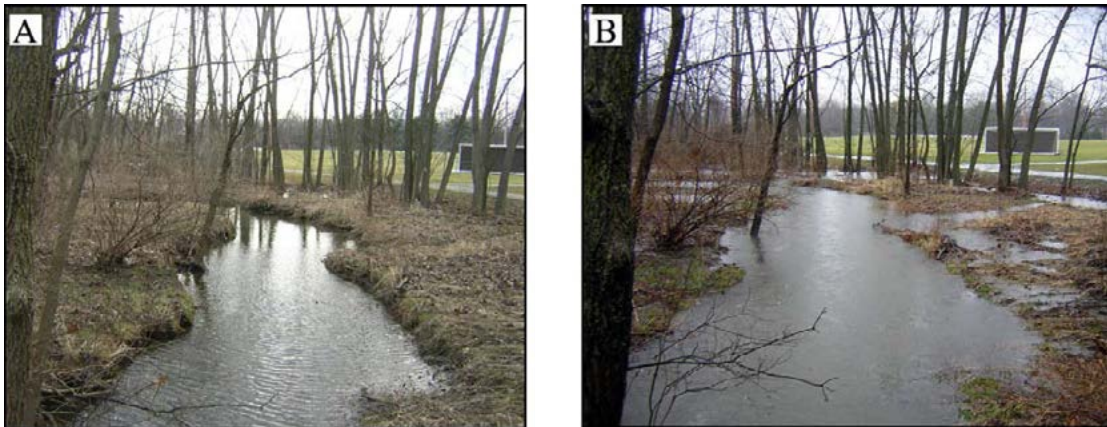
Figure 1. A small urban stream with a connected active floodplain containing less than the bankfull discharge; note the distinct shape and size of both stream banks. B: The same stream with a bankfull, or channel-forming discharge, after a rainstorm.

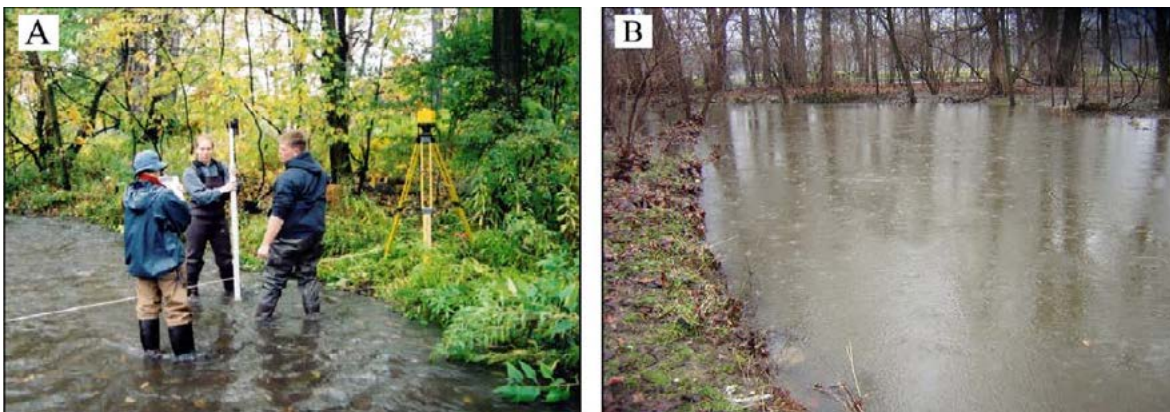
Figure 3. A: Measuring bankfull features in an urban stream. B: Bankfull flow in the same stream with water depths and currents that make taking measurements unsafe.

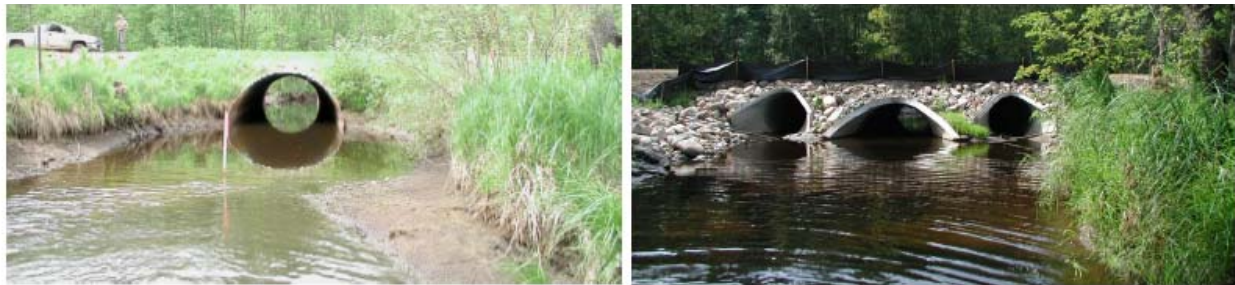
Figure J.2
Comparison of Undersized and Adequately Sized and Placed Culverts

Undersized culvert.

Properly sized and placed culverts.
